**REQUEST FOR QUOTATIONS
HISTORIC BASEBALL GRANDSTAND RESTORATION**

**CONDITIONS ASSESSMENT REPORT
FOR THE**

GRANDSTAND at NICHOLS PARK SPENCER (TIOGA COUNTY), NEW YORK

APRIL 28, 2018

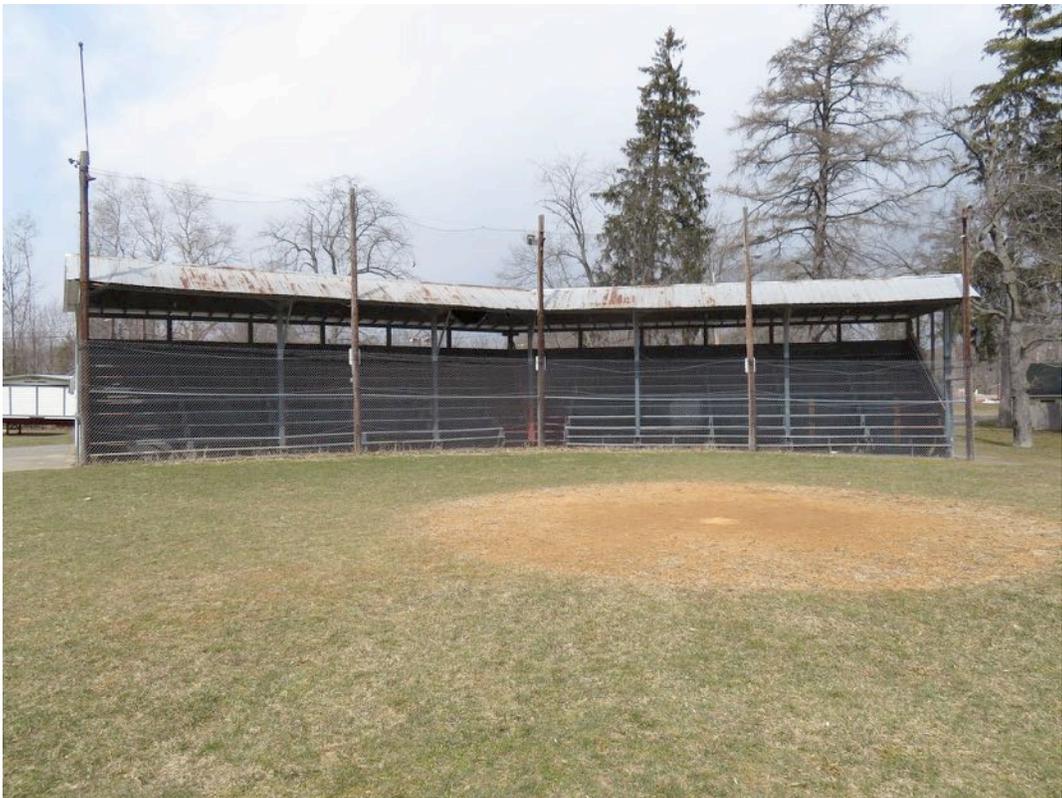
The roofing appears to be galvanized steel that has been painted over the years with an “aluminum” coating, a silver colored bituminous product that’s commonly used for such purposes (See photo 1). This type of roofing is fastened with screws or sometimes nails down through the top of the rib which can lead to deterioration and leaks.

As a practical safety measure, at some point the Village elected to install backstop screening to protect those in the bleachers from errant baseballs (See photo 1). This screening is supported by five 8” diameter (tapered) wooden poles spaced equally from the western side of the bleachers to the eastern and extending well above the roof line.

Photo 1: South face of grandstand looking north.

- 2.1 Inspect the metal roofing at close hand and secure and seal any compromised fasteners. Consider coating the roofing with an elastomeric product such as AcryMax which can be reinforced with a mesh fabric to span small holes or damage.
- 2.1 Check all roof framing at close hand to identify any minor splits or other problems and make repairs as necessary.

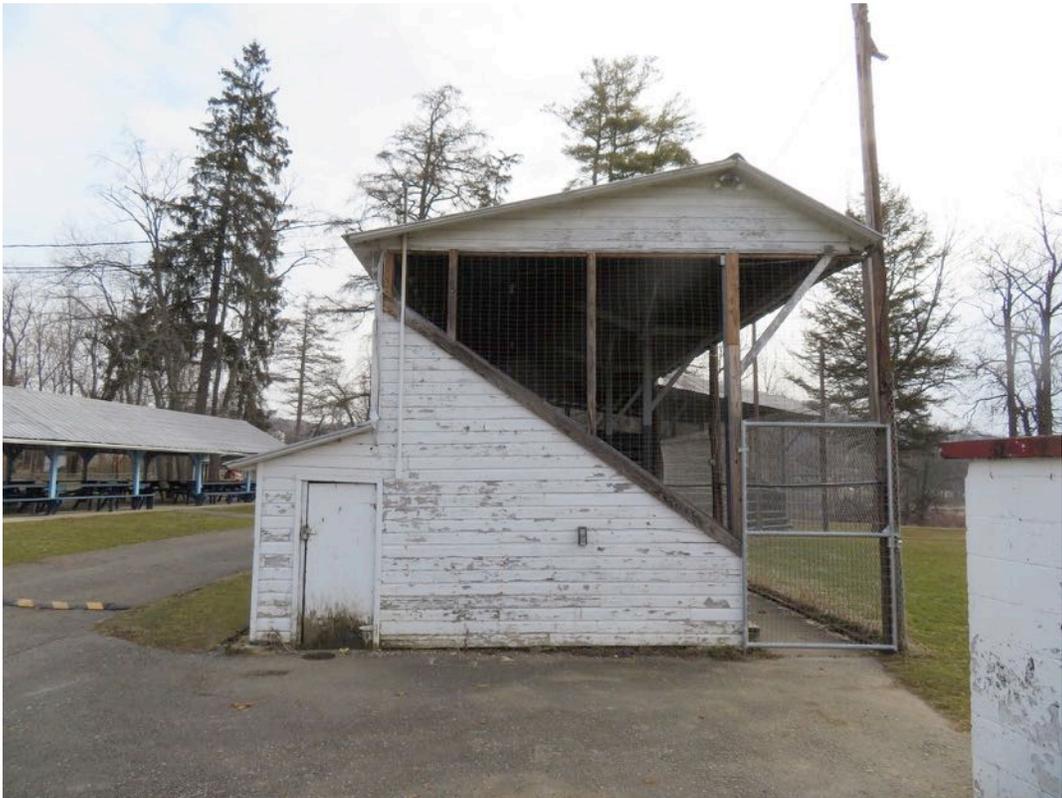
The rear and end walls of the bleachers consist of wood stud walls (in line with the roof posts and stepped supports for the seat and foot boards) covered on the exterior by wood shiplap siding with a 5" reveal (See photos 2-8). This siding has been repaired nominally in several areas, but is generally deteriorated and in need of more comprehensive repairs and repainting.

At the end and rear walls of the grandstand additional screening has also been added at the open sides, presumably for safety rather than security (See photos 2, 6). This screening is older and rusty.

Photo 2: Southwest face of grandstand looking northeast.

- 3.1 Replace the string screening with chain link similar to the lower portion and secure it carefully to the poles.
- 3.2 Replace the screening in the end and rear walls with new galvanized mesh.

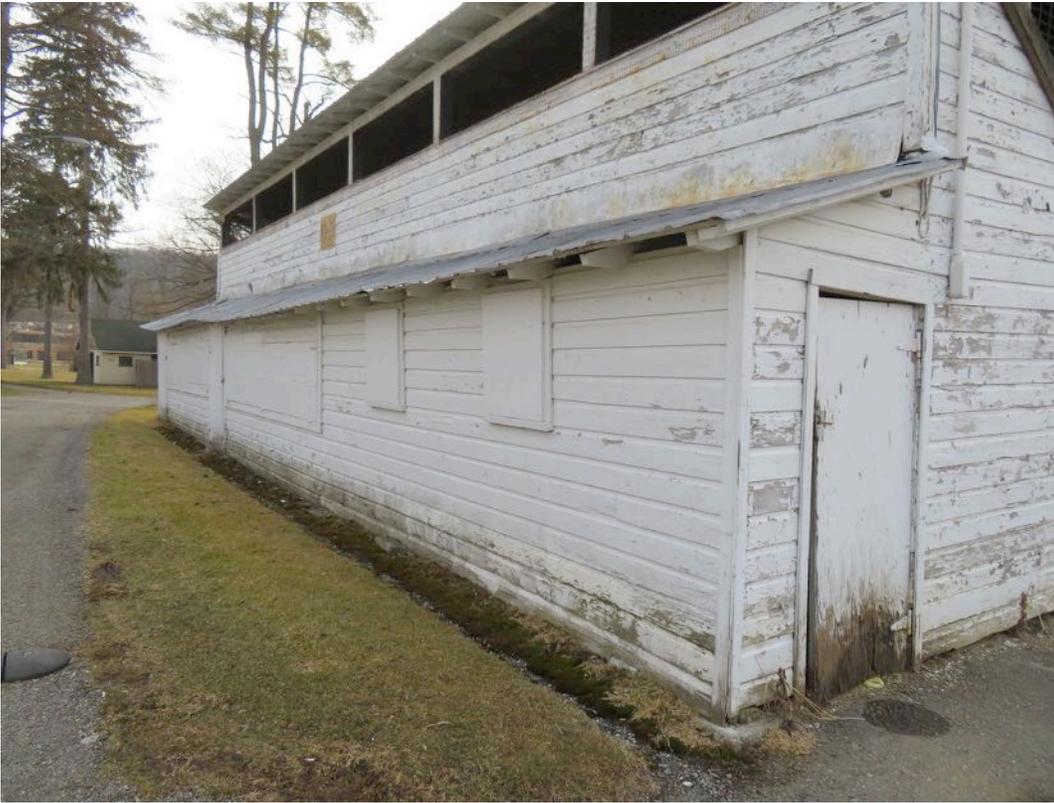
At the northwestern end of the structure, except for a shallow drip line, the blacktop driveway and grade are slightly above the bottom of these outer walls and surface water (in conjunction with roof runoff) has contributed to deterioration (See photo 3).

The shed space doors are plywood with flat wood 2x4s at the perimeters (See photos 3, 20), surface mounted hinges, and hasps with padlocks. The doors are somewhat flimsy and inconsistent with the character of the structure.

Photo 3: Looking easterly, northwest face of grandstand at left. Note projection of shed.

- 4.1 Excavate a trench between the drive and the building at the southwest and northwest sides of the shed. Install a subsurface drain line to daylight (location to be determined) and cover it with crushed stone leaving a shallow trench. Span the trench with pressure treated decking even with grade and spaced so that surface water flows into the trench. This will minimize water damage to the bottom of the walls. (A similar treatment could be considered along the northeast side as well.)

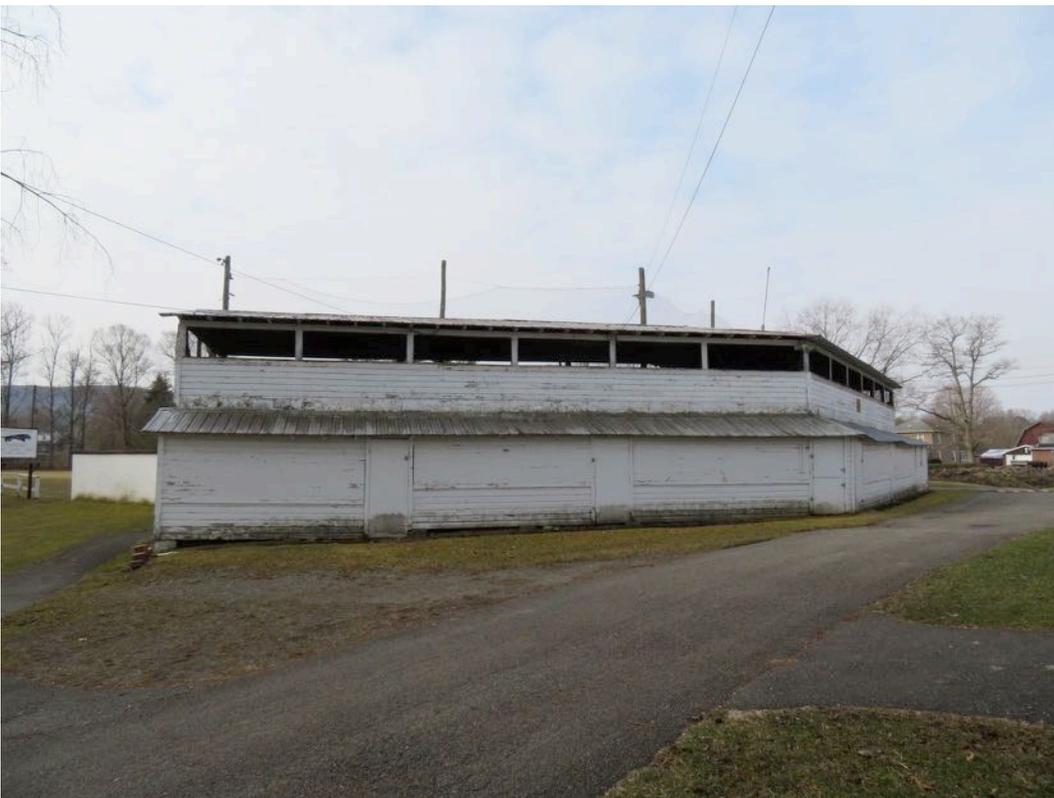
Photo 4: Looking southwesterly towards northeast face of grandstand. Note how grade slopes down to the southeast corner.

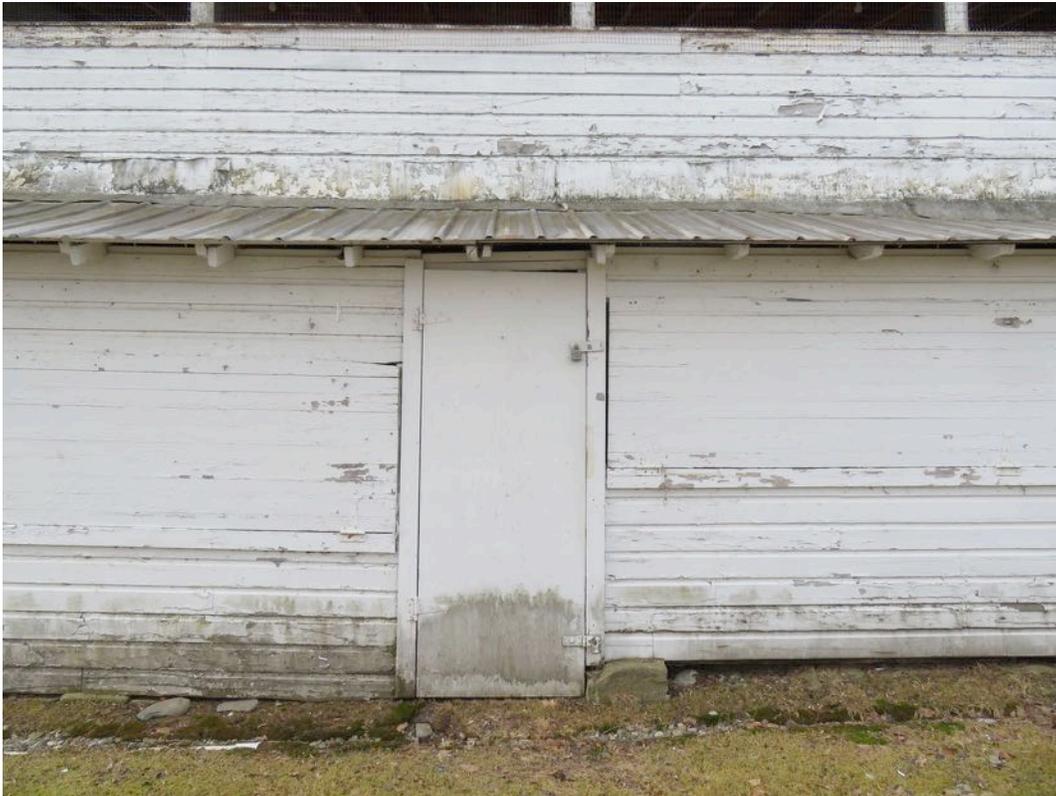
At both wings of the shed, rainwater coming off the roof hits the ground and splashes back up against the exterior walls leading to additional deterioration (See photo 5).

Water from the upper roof drops onto the shed roof and the splashback causes damage to the rear wall of the bleachers (See photo 5). As a consequence the Village has extended metal flashing up the face of the wall more than two courses of siding, but the joint is not fully protected by counter flashing and water can get behind it.

Photo 5: Detail of door into shed space B. Note sag in wall at doorway as well as roof, splashback damage at grade and upper wall, and typical roofing.

- 4.7 Add sisters matching the current rafter tails to reinforce the extended shed roof and modify the eave to accommodate half round galvanized steel gutters to control roof water and minimize splashback damage to the exterior walls. Reduce the width of the service windows in some locations by 6" to accommodate periodic downspouts from the gutters.

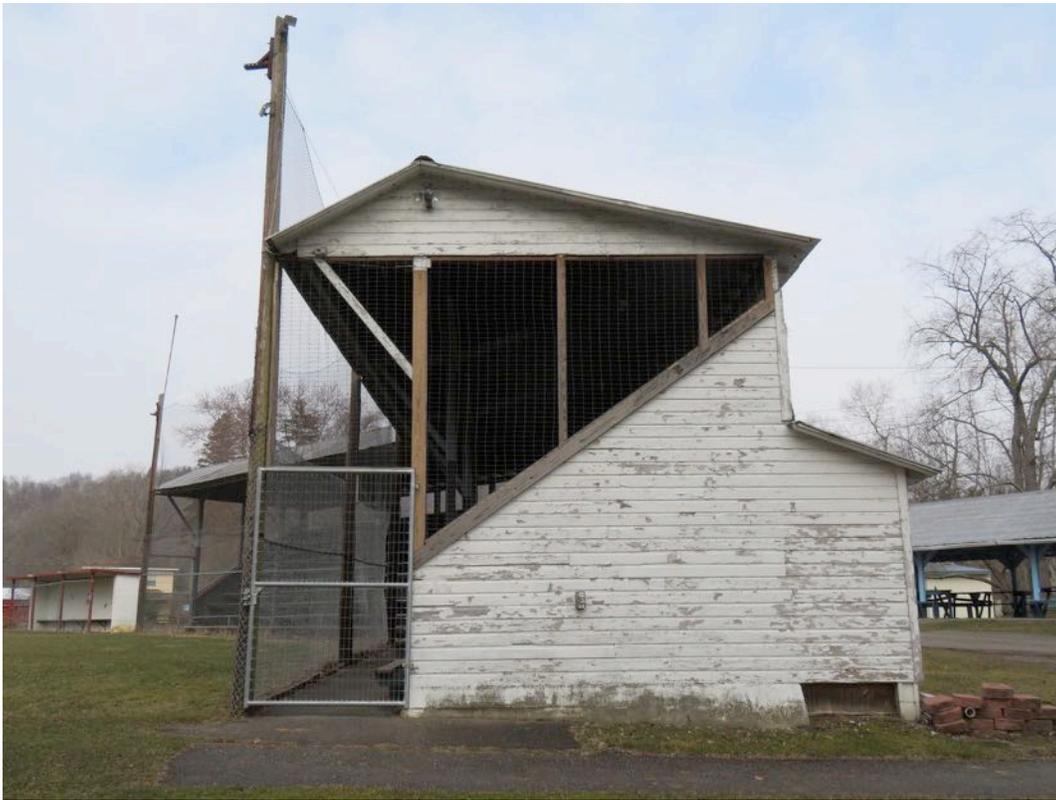
Since grade slopes down to the southeastern parts of the shed and the concrete grade beam supporting that end keeps the framing above ground level this is less of a concern there (See photo 6).

Photo 6: Southeast face of grandstand, looking northwesterly.

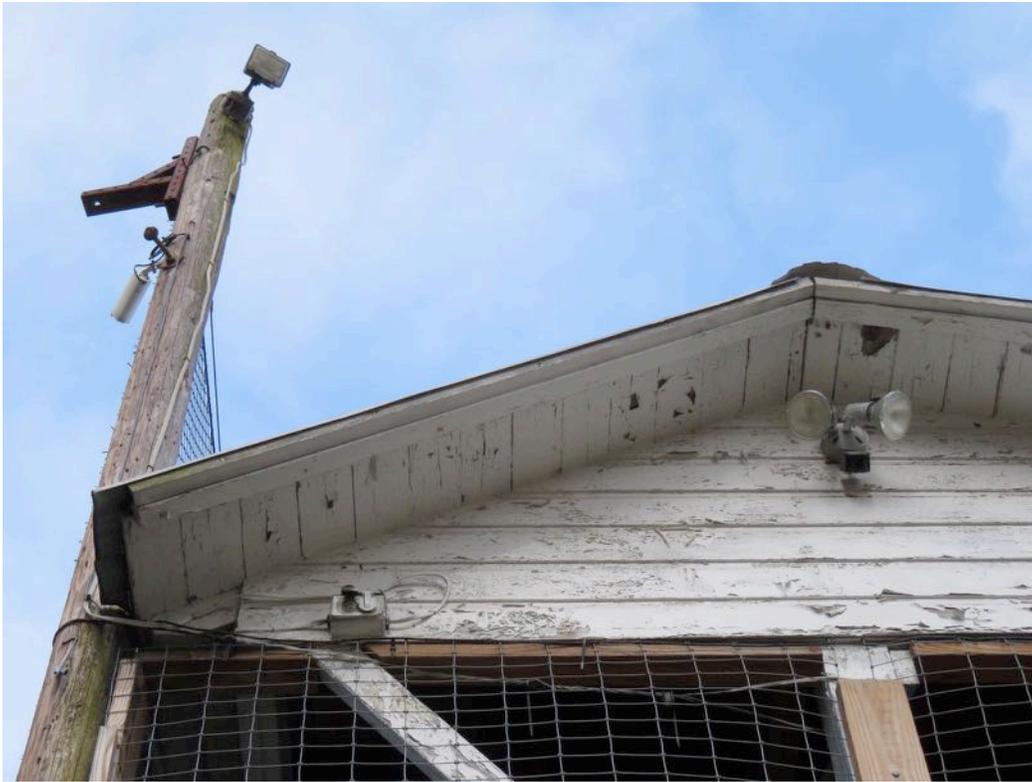
Photo 7: Detail at upper portion of southeast face of grandstand. Note miscellaneous electrical and backstop screening pole.

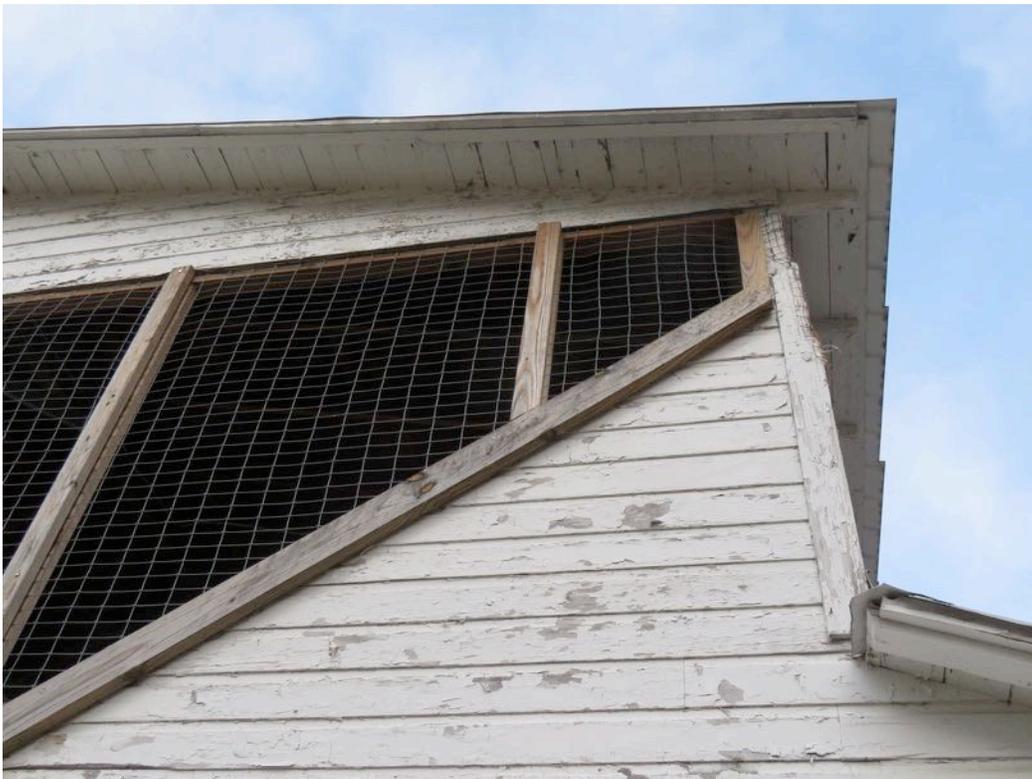
Photo 8: Detail at upper portion of southeast face of grandstand. Note protective screening secured with unfinished 2x4s.

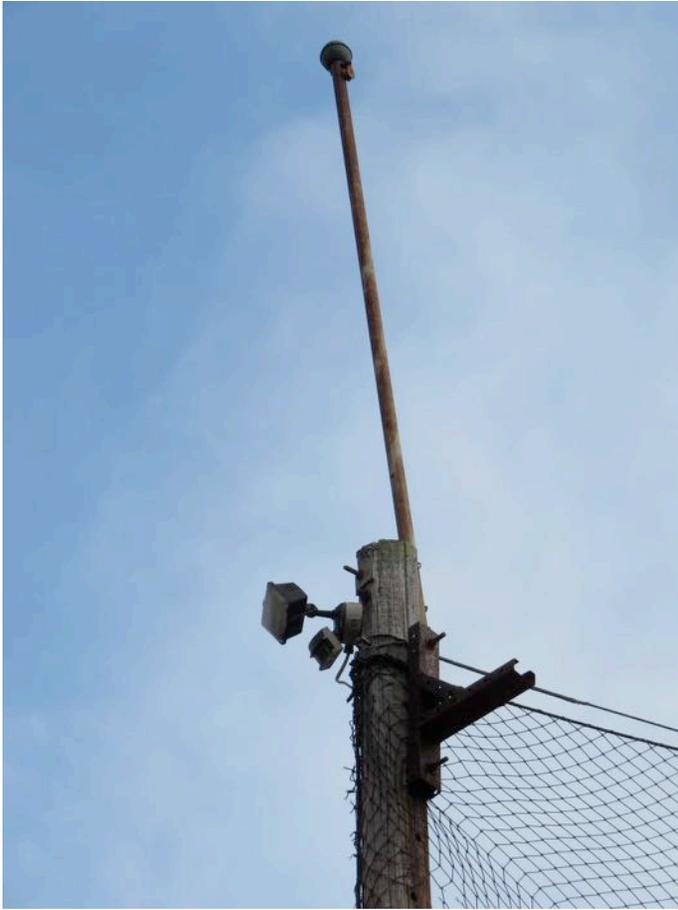
Photo 9: (left) Detail of flagpole at southwest backstop screening pole.

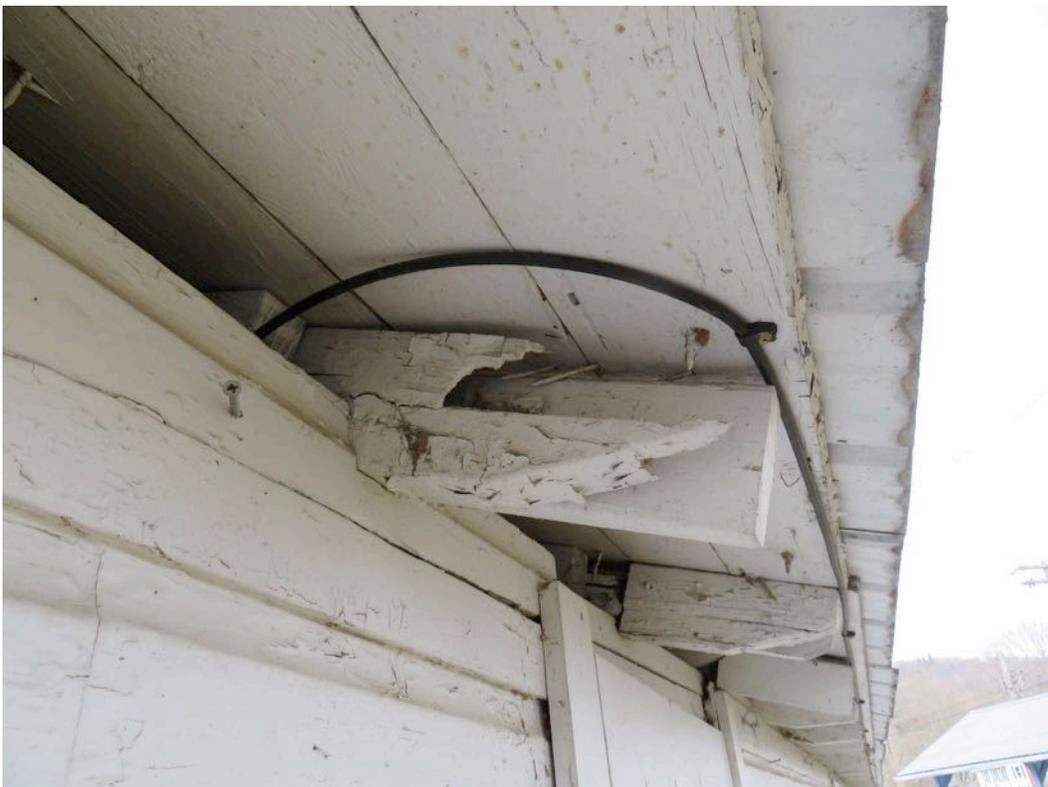
The roof of the shed projects out beyond the rear wall of the bleachers and consists of wood 2x4s at 24" on center, 1" tongue & groove wood board sheathing, and the same metal roofing as the main roof. A number of these rafters have split or otherwise deteriorated (possibly due to winter ice falling off the higher roof above) and been haphazardly reinforced (See photos 10, 21).

Photo 10: (below) Detail of deteriorated roof rafter tail with mis-matched reinforcing sister at shed.

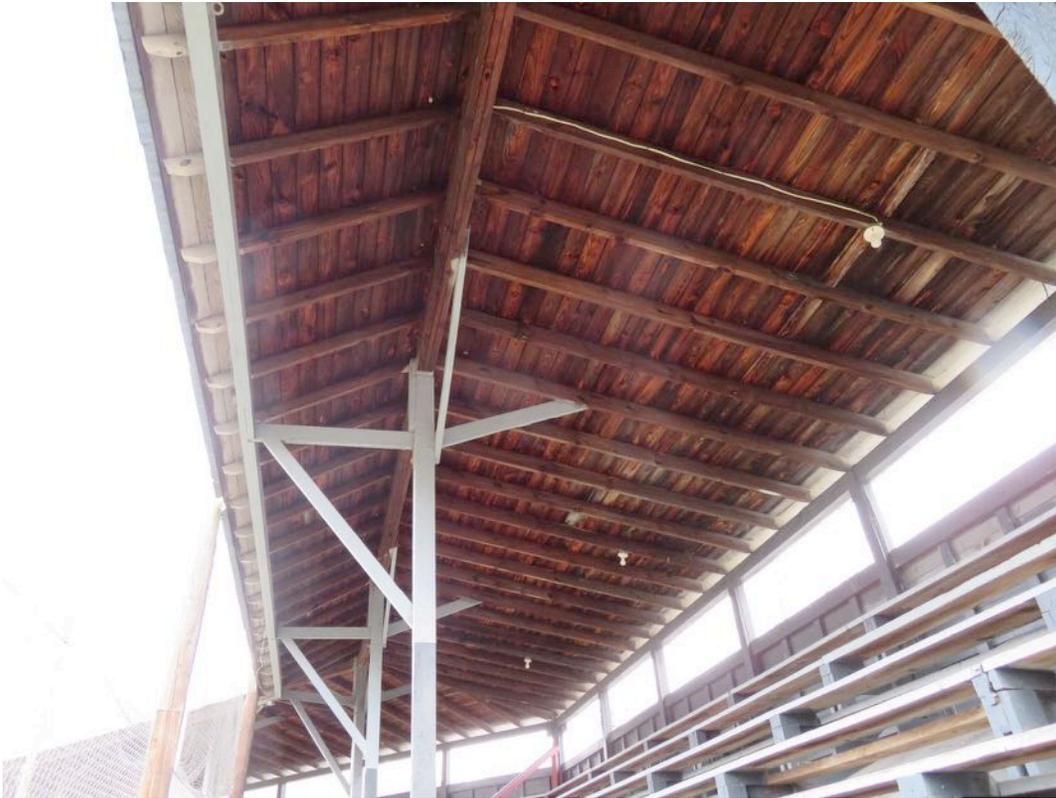
The roof above the bleachers is supported by built-up wooden posts generally comprised of several wooden 2x6s secured together (See photos 11-14). This is an effective form of construction that minimizes the number of different framing members needed and which produces a stronger member than a single, say, 6x6 which would be more vulnerable to splitting and twisting.

These posts are integral with the stepped supports and extend up to carry a ridge beam which supports the roof rafters (See photo 11). The roof rafters are wood 2x6s (1 5/8" x 5 5/8") at 24" on center running front to back supporting 1" nominal tongue & groove wood sheathing and corrugated metal roofing with larger ribs every foot or so. The rafters (or

Photo 11: General view at grandstand roof framing from below.

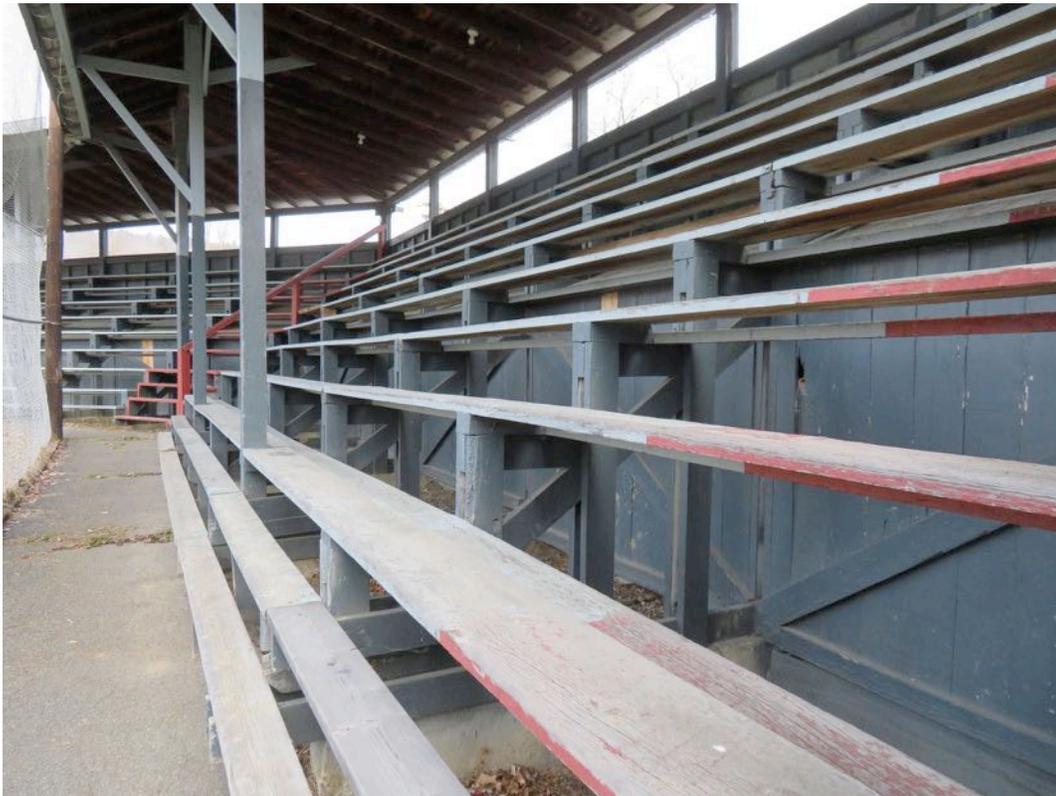
Adjacent to the center line between the east and west wings additional steps have been installed in the 4' wide area noted above, apparently in an effort to make it easier and safer to access the lower rows of seats (See photo 12), but they're still difficult and somewhat dangerous, especially since the handrails don't extend down past the last roof support post.

In front of the bleachers themselves and behind the backstop screening is a blacktop walk roughly five feet wide. It's somewhat rough and weeds grow up through various cracks (See photo 12).

Photo 12: General view of bleacher seating looking northwesterly. Note red-painted steps at far end and vertical boards under seats at right forming back wall of shed spaces.

- 6.1 Remove the weeds and patch the cracks for now. As funds permit, consider replacing the walk with new blacktop or possibly adding a topping to the existing.
- 6.2 Verify the condition of the 6x6s between the poles and replace them as necessary.
- 6.3 Carefully repair, prep, and repaint all currently painted portions (and repairs or replacements) of the entire structure. Have the existing paint tested for possible lead

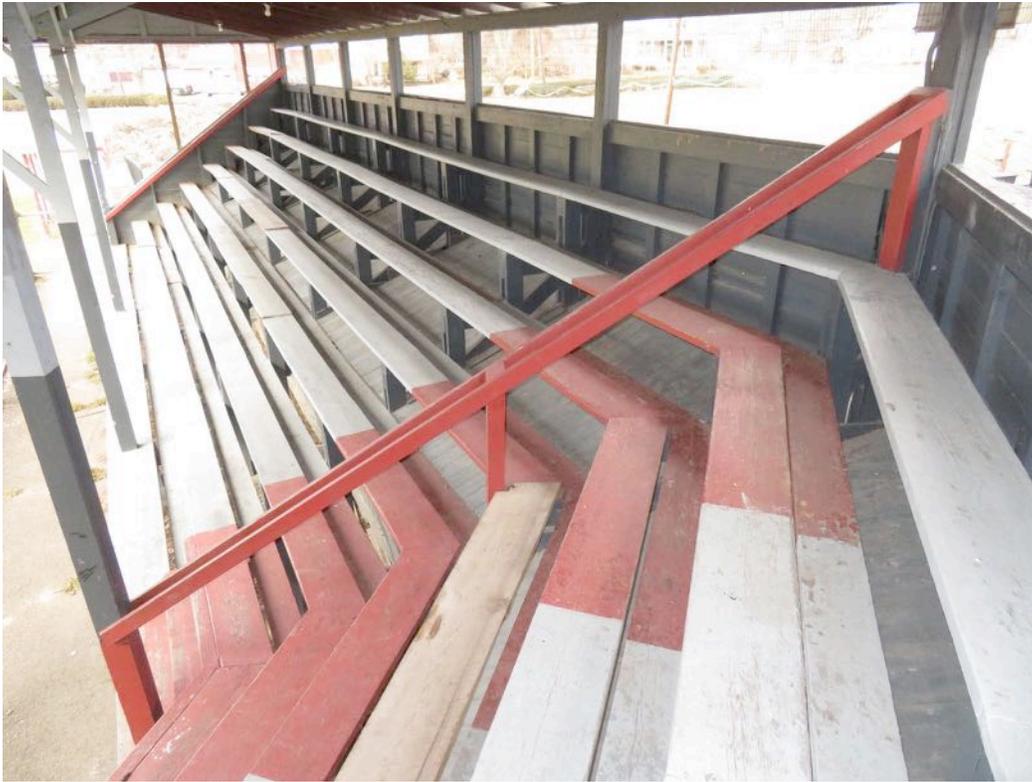
Four foot widths of the seats and foot boards at the ends of both wings of the bleachers (See photo 13) have been designated as steps (albeit steep steps) and are painted red to differentiate them from the actual seating. Handrails consisting of wood 2x4s with their narrow faces "up" have been installed at one side of these routes, but they aren't readily graspable.

Photo 13: Bleachers from above looking northwesterly. Note red-painted steps with 2x4 handrails at center.

- 1.5 Consider options for adding intermediate steps in the red-painted access sections to make climbing easier.
- 1.6 Consider alternative provisions for wheelchair seating outside the grandstand. The lower seats could be modified to provide sufficient room, but functionally and legally these viewing spaces would have to be at least 3' wide by 4' deep from the face of the lowest seats which would greatly alter the historic character of the bleachers.

- 1.7 Install steel pipe handrails with metal brackets projected on the faces of the current 2x4 "handrails" and extend the bottom portions a foot or more to provide additional support at the lowest level. Round pipe, 1 1/2" maximum ID, is much more graspable than the 2x4s.

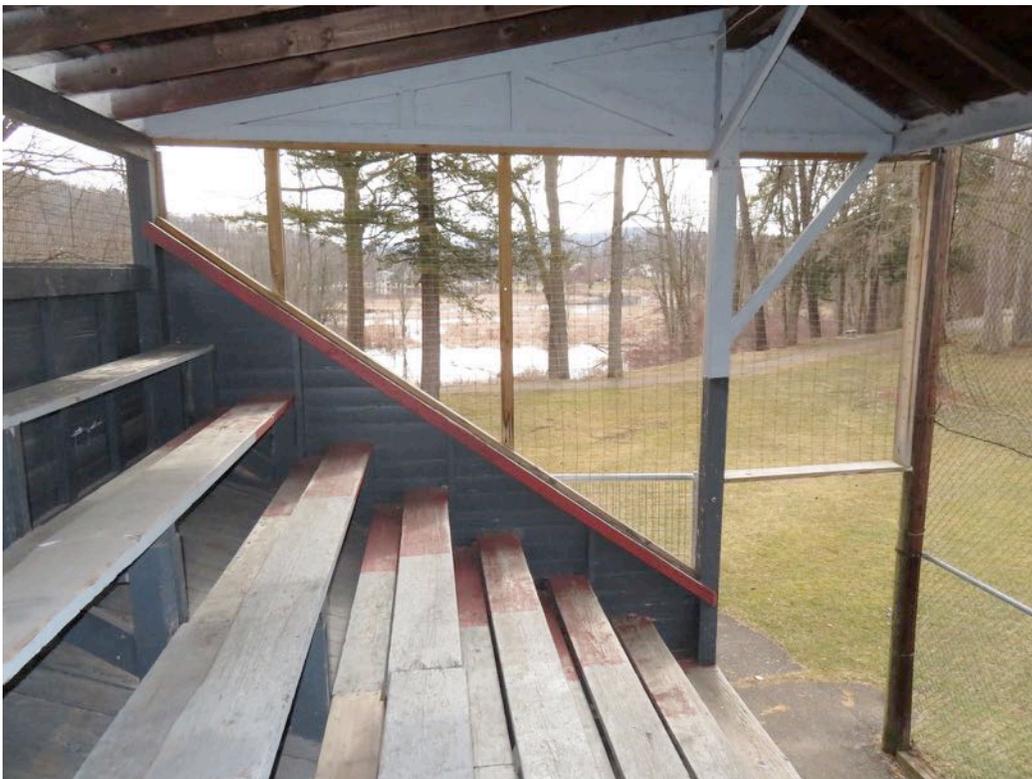
Photo 14: Looking southeasterly to interior face of southeast wall of grandstand. Note red-painted steps with handrail and wood truss supporting roof.

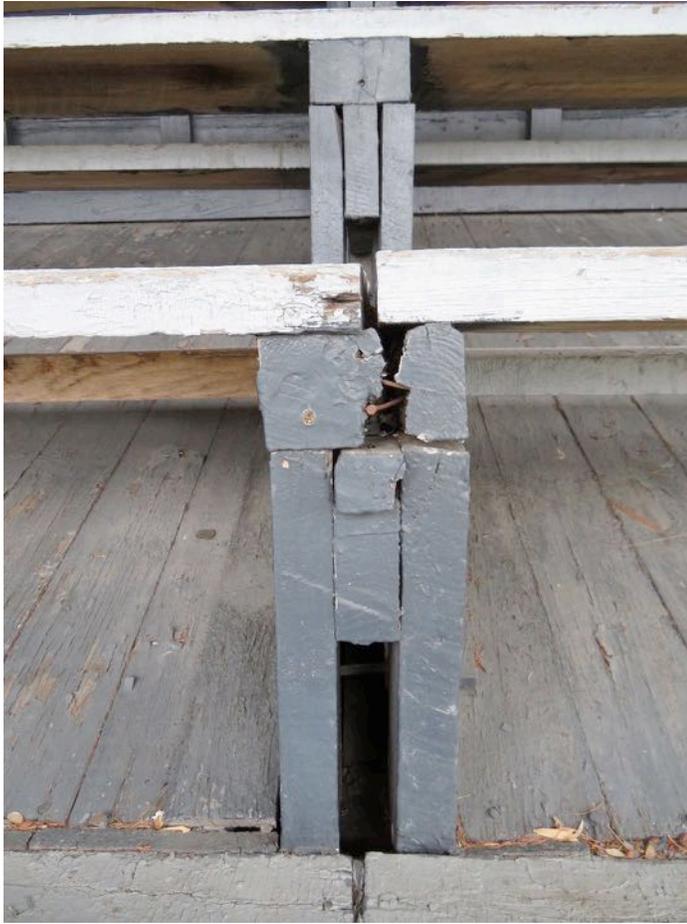
Some of the pieces comprising these stepped supports have split, deteriorated, or otherwise failed (See photo 15) and been replaced or reinforced with newer pieces of wood. These repairs are generally sufficient structurally, but aren't always consistent with the historic character of the bleachers.

Photo 15: (left) Detail at face of typical stepped support for bleachers.

- 1.3 Make additional repairs to the framing of the stepped supports as necessary and match the original construction as closely as possible, including in the dimensions of the wood members used.

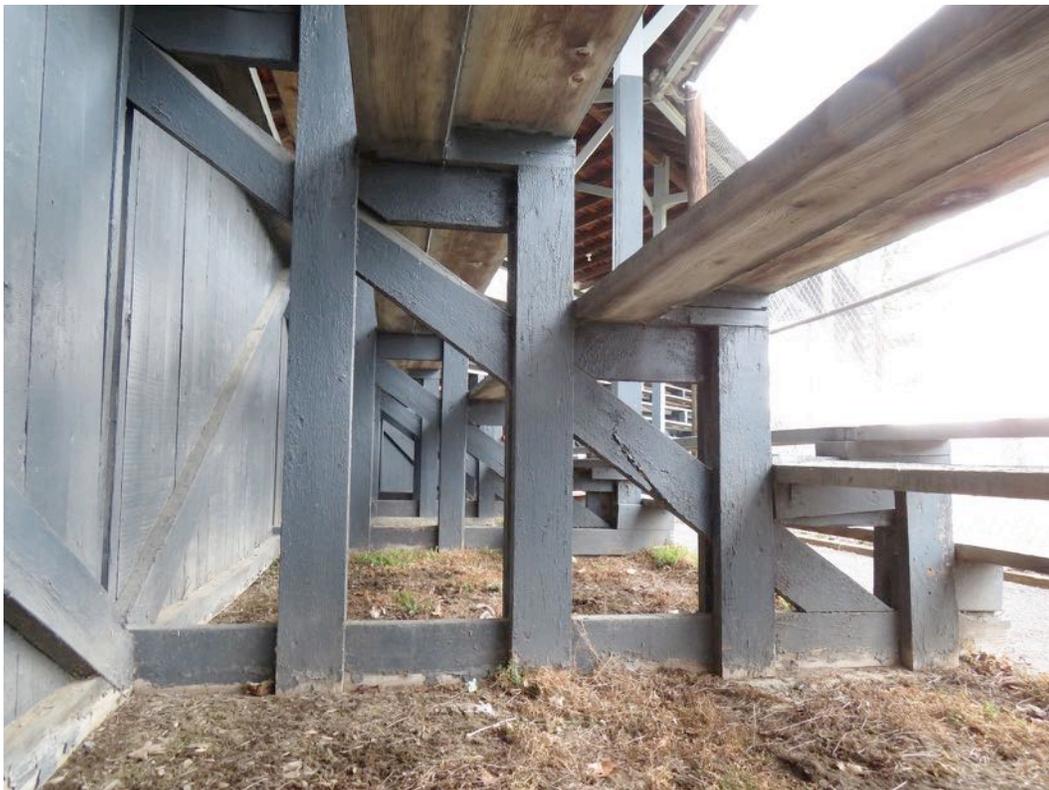
In general grade slopes gently down from the west end of the bleachers to the east end, dropping roughly 18" in all. The tops of the western three or four of these grade beams sit a couple of inches below grade (See photo 16) and as a consequence the bottoms of the stepped wooden supports bearing on them are exposed to moisture that has led to varying degrees of deterioration.

Photo 16: (below) Side view of typical stepped support for bleachers. Note that top of concrete grade beam is at or below grade encouraging moisture damage to the wooden support.

- 1.1 Excavate a few inches between the stepped bleacher concrete supports and install gravel to below the level of the concrete so that rain and melting snow can drain away without deteriorating the bottoms of the wooden supports.

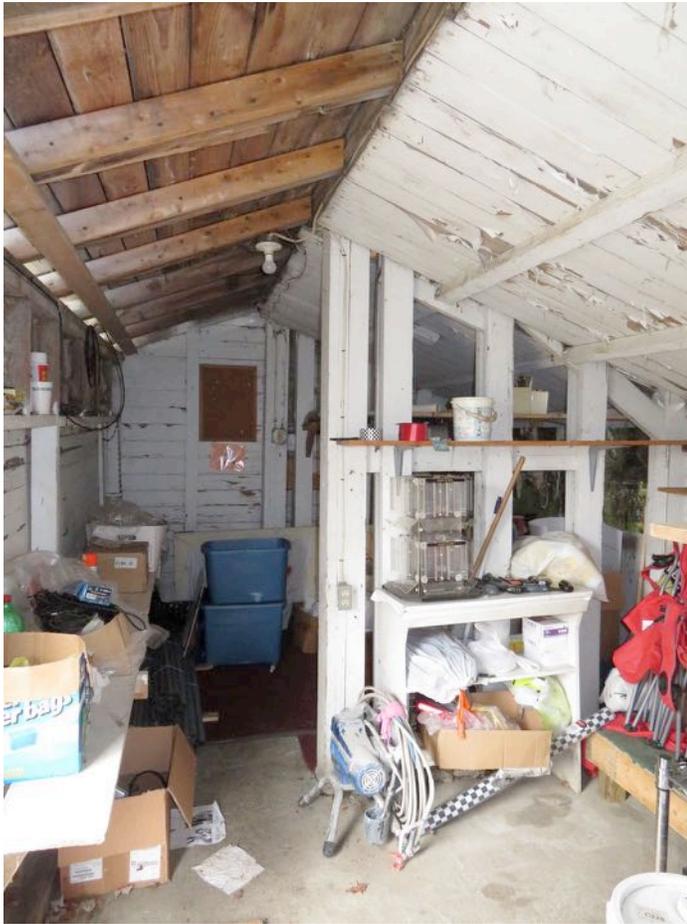
Photo 17: (left) Looking southeasterly in shed spaces A and B. Note stepped bleachers support and that underside of projected roof is unfinished while all other surfaces are painted.

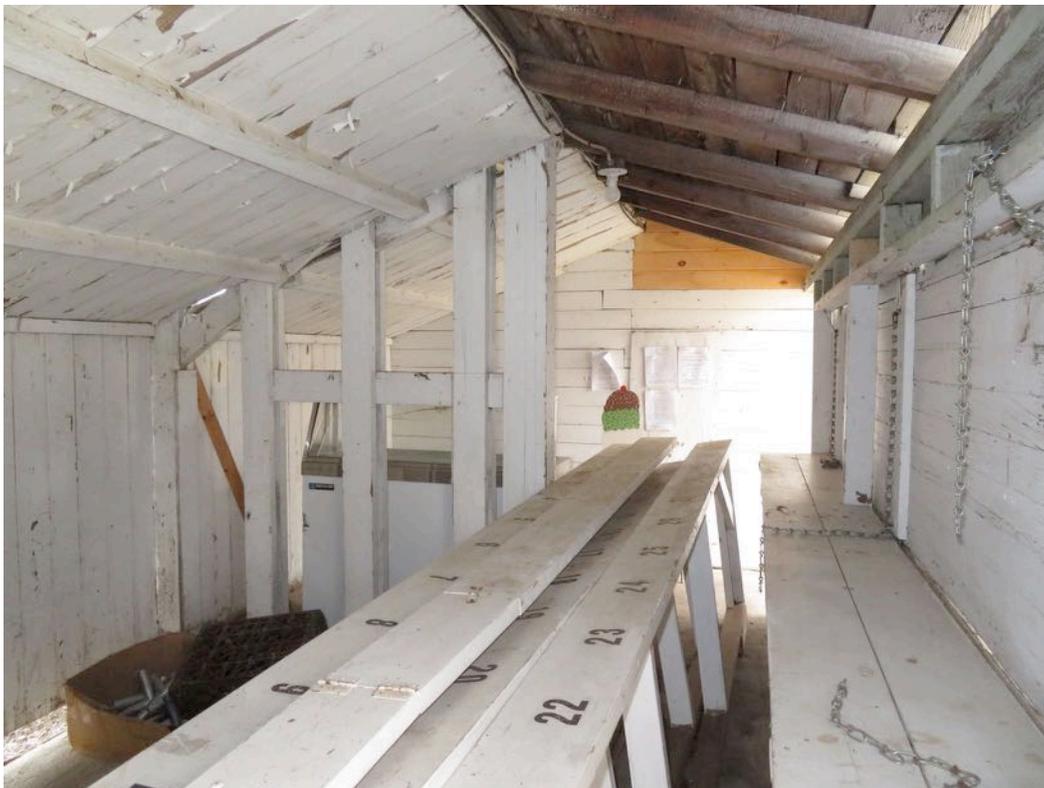
Photo 18: (below) Looking northwesterly inside shed spaces C and D. Note counter and bottom-hinged, drop-down, service window cover at right.

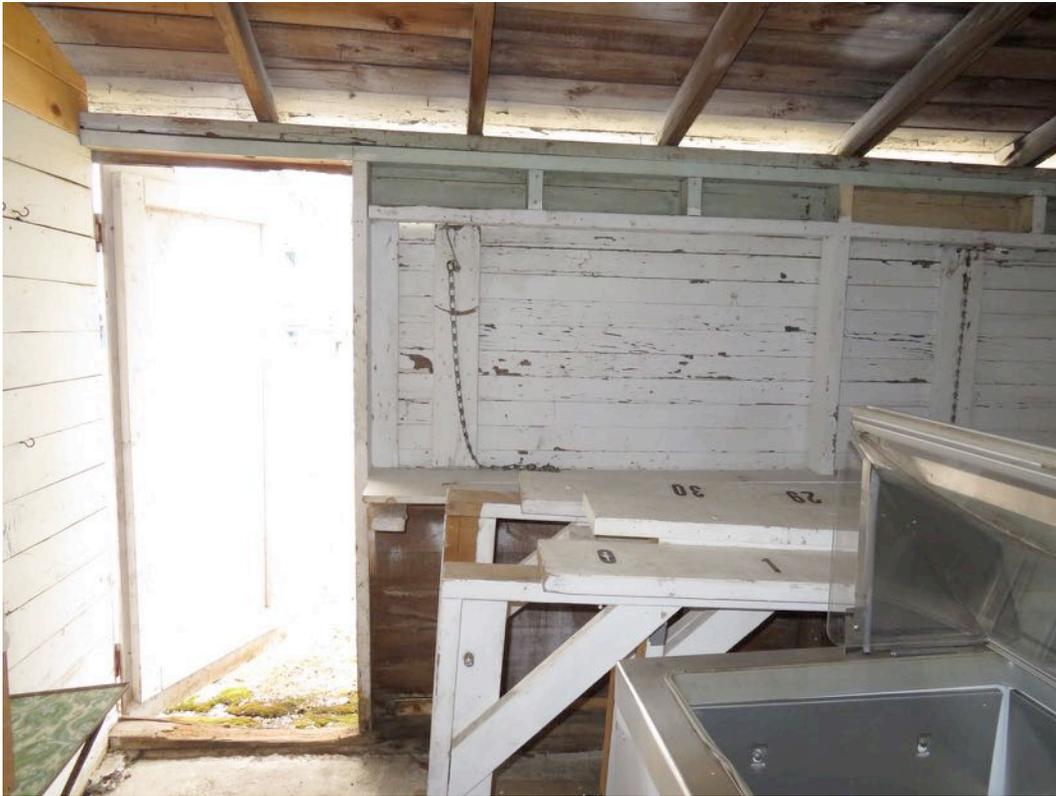
Photo 19: Looking northeasterly to interior face of exterior wall at shed space D.

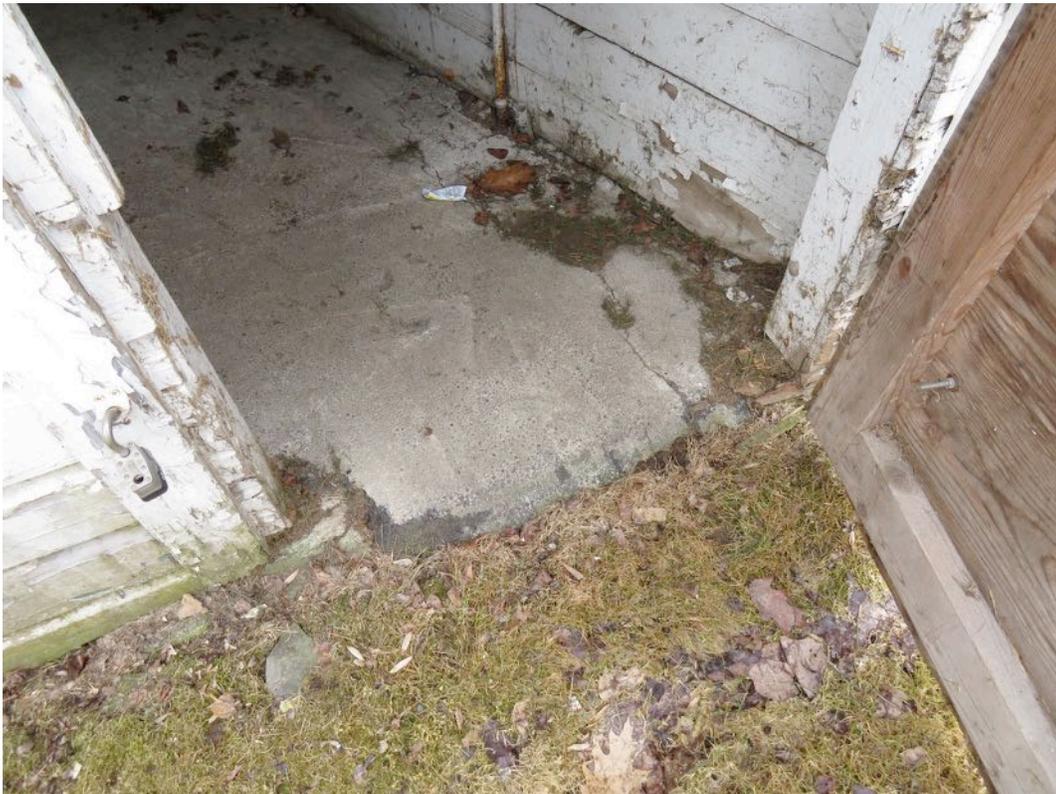
The floors within the shed spaces are blacktop, roughly placed but generally effective for the intended purpose (See photos 20, 22, 24). In most areas, however, the blacktop extends above the bottoms of the wood framed walls leaving them vulnerable to water damage.

Photo 20: Detail at sill of shed space. Note that blacktop covers wooden sill.

- 4.6 If at all possible, remove the blacktop and provide new concrete floors inside the shed spaces, detailed to avoid water damage to the wood framing systems.

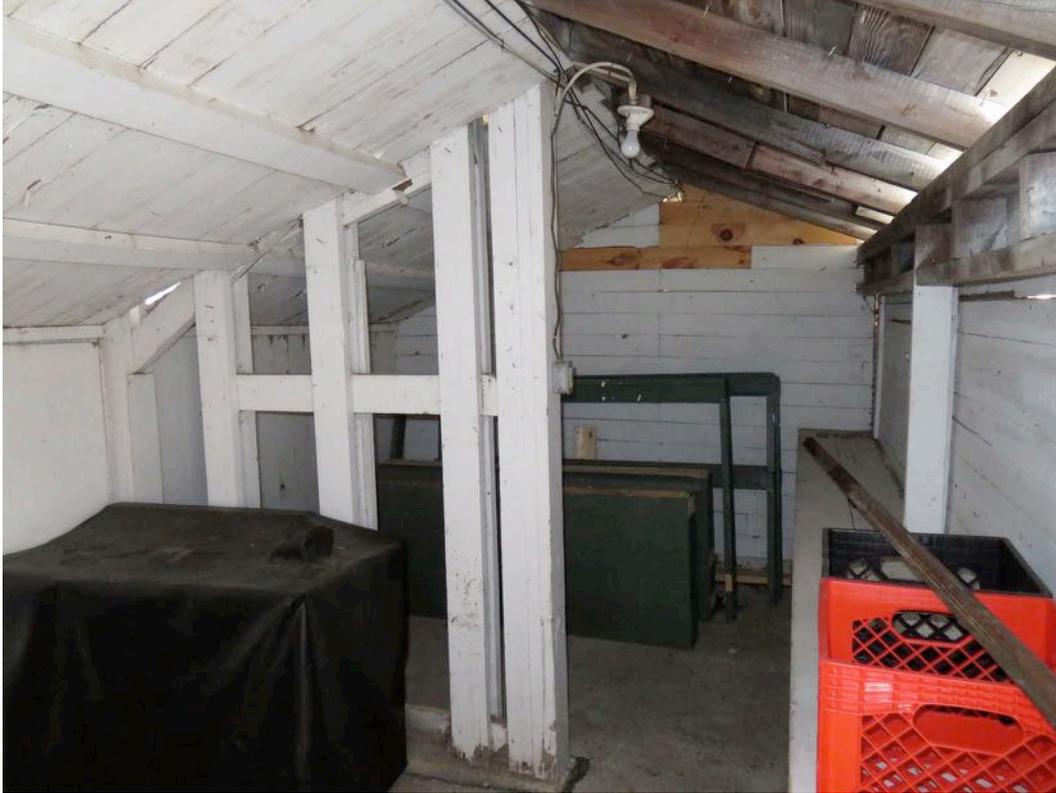
Photo 21: Looking southwesterly inside shed spaces G and H. Note split and repaired shed roof rafters (unfinished).

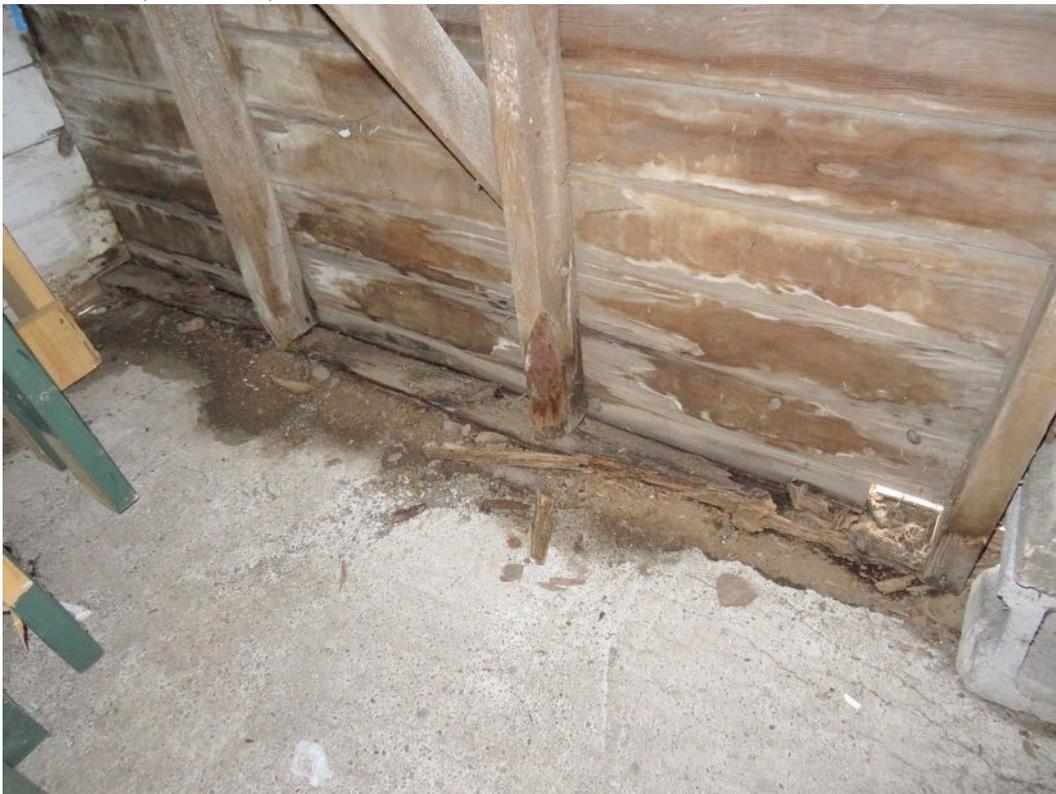
Photo 22: Detail of typical deteriorated wood sill and lower wall inside shed space H.

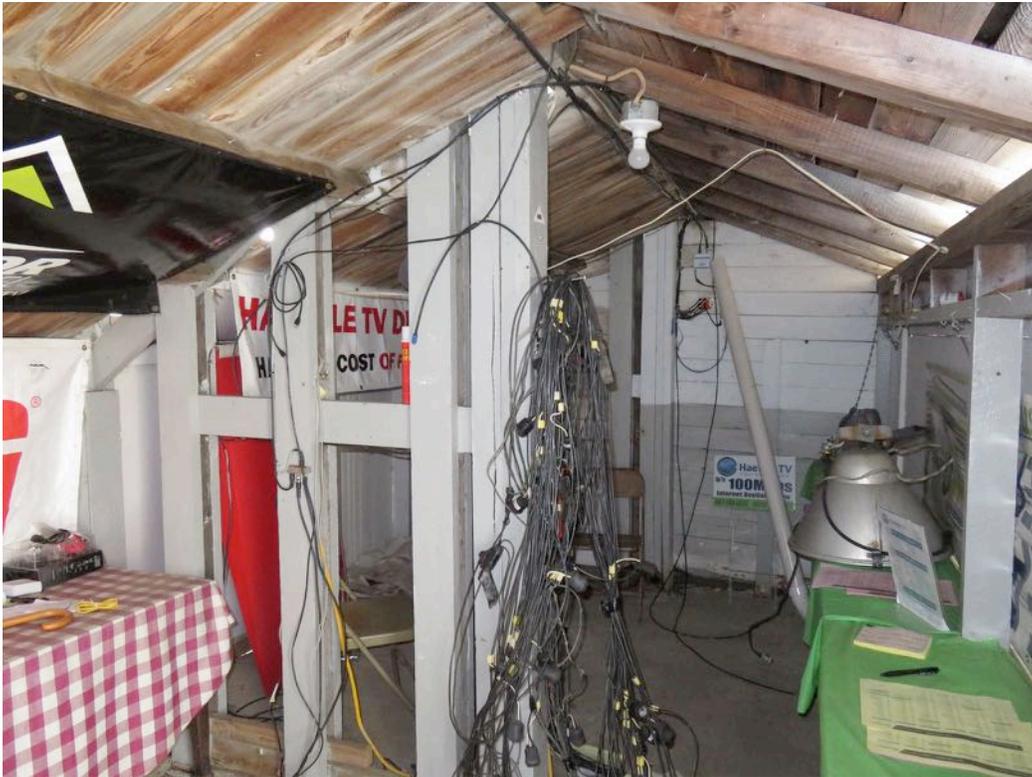
There are no mechanical or plumbing systems in the structure, but it does have an electrical system and loudspeakers as well as cable (See photos 23, 26). No obvious problems were noted, but the system was not investigated in detail. The electrical service enters overhead from the northwest and a subpanel was noted in the first bay of the shed there. Most if not all wiring is surface-mounted Romex. Most if not all outlets are GFI-protected. Switches couldn't be located for the ceiling lights in several of the shed spaces and these fixtures consist of open sockets with bare incandescent bulbs (as do those at the ceiling of the bleachers). No fire or smoke detectors were noted.

Photo 23: Looking southwesterly inside shed spaces I and J. Note miscellaneous cable TV wiring (not other wiring coiled on nail in foreground).

- 5.1 Have the existing electrical system (including distribution, devices, and fixtures) inspected by a qualified electrician to verify their condition and safety.
- 5.2 Replace all open socket light fixtures with protected ones using either lenses, shades, or cages to reduce the potential for accidental breakage and related damage or injury.
- 5.3 Consider replacing all bulbs with more energy efficient versions.
- 5.4 Consider installing at least battery operated (though preferably hard-wired and connected to a monitoring station) fire & smoke detectors with alarms in the shed spaces and perhaps even the bleachers.
- 5.5 If the grandstand's exterior lights aren't connected to motion sensors consideration should be given to doing that for security.

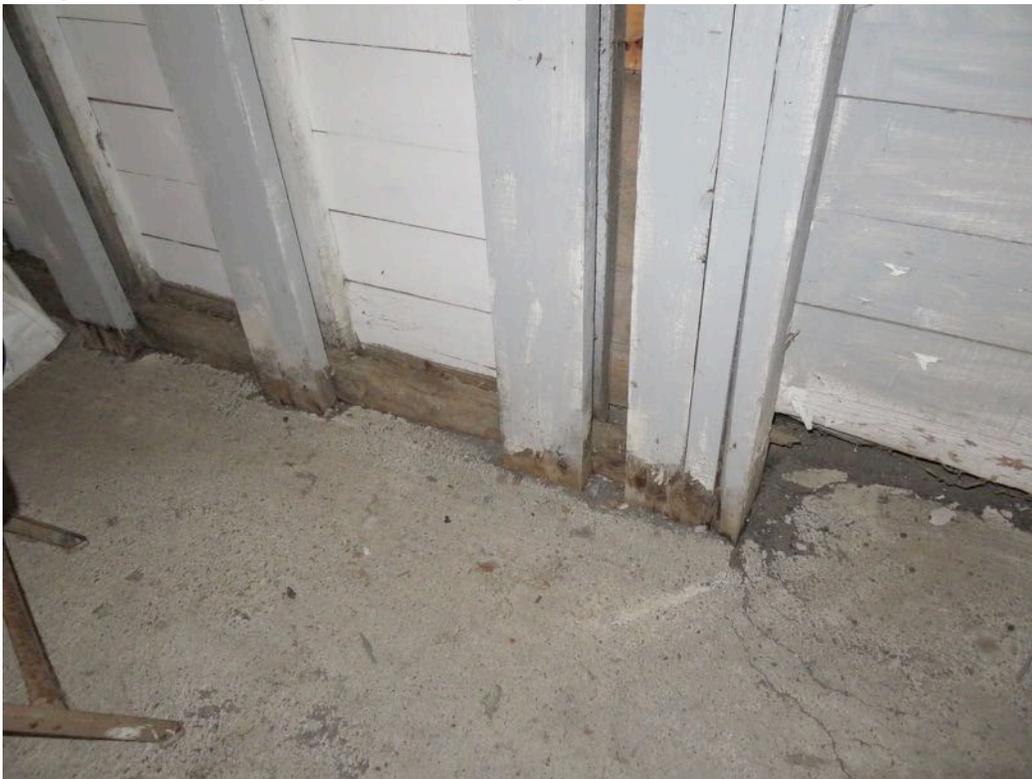
Photo 24: Detail of blacktop inside shed space burying wooden partitions and contributing to deterioration.
