**REQUEST FOR QUOTATIONS
HISTORIC BASEBALL GRANDSTAND RESTORATION**

**CONDITIONS ASSESSMENT REPORT
FOR THE**

GRANDSTAND at NICHOLS PARK SPENCER (TIOGA COUNTY), NEW YORK

APRIL 28, 2018

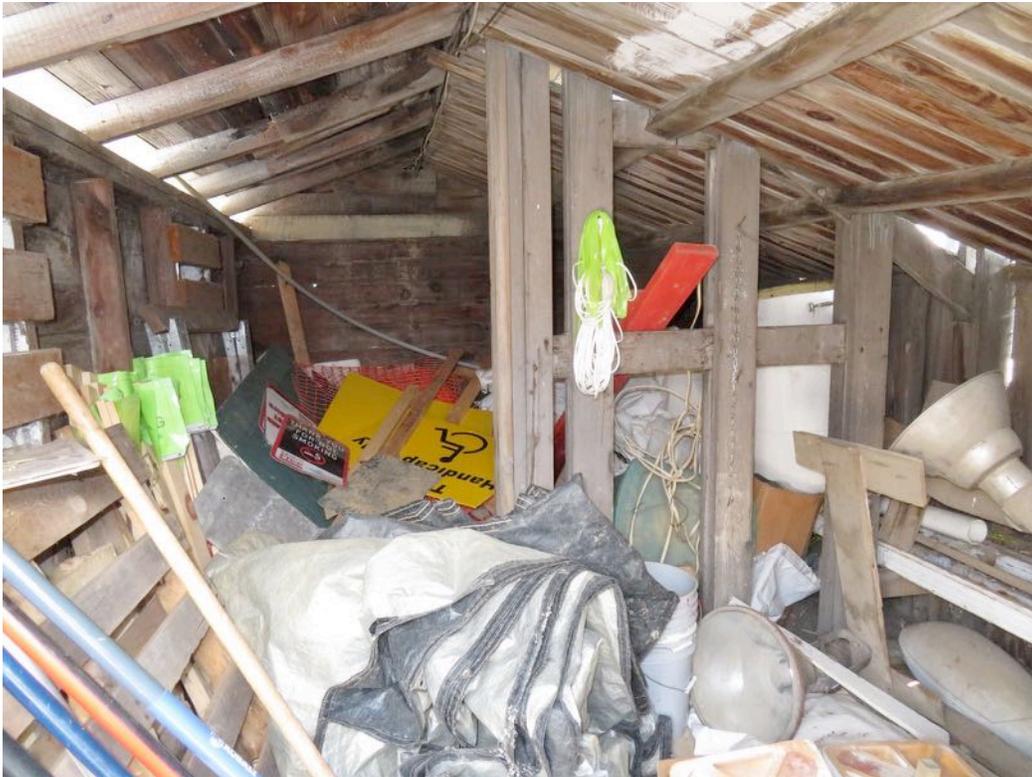
Photo 25: Looking southwesterly inside shed spaces K and L. Note accumulated debris and repaired shed roof rafters.

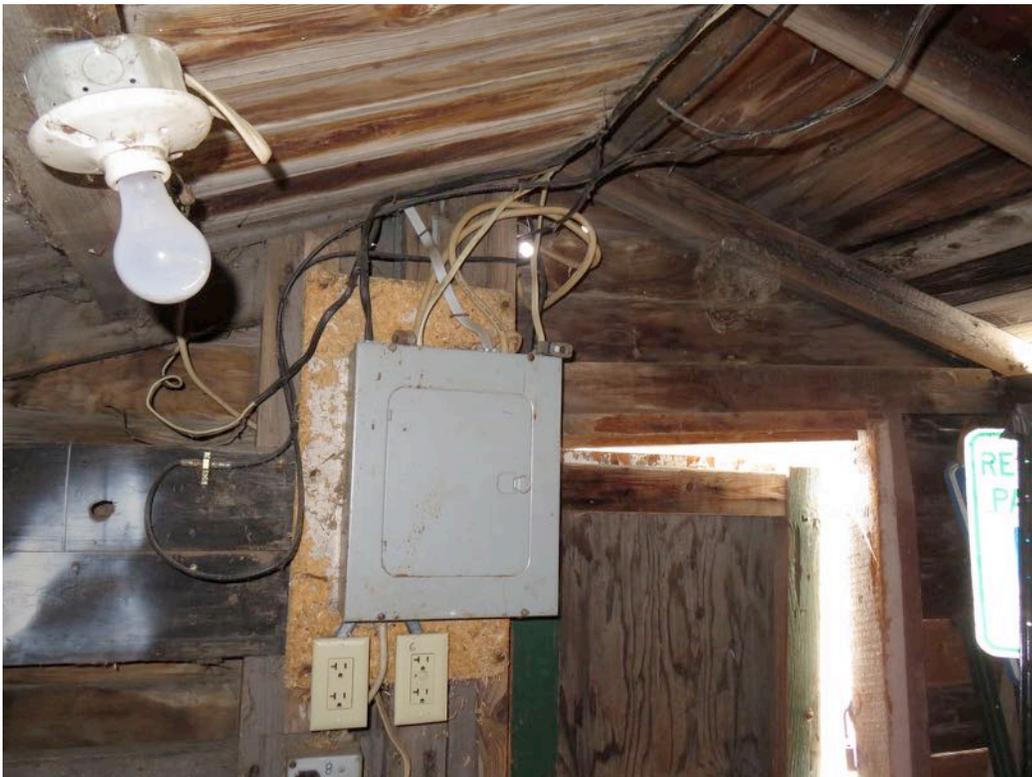
There are no mechanical or plumbing systems in the structure, but it does have an electrical system and loudspeakers as well as cable (See photos 23, 26). No obvious problems were noted, but the system was not investigated in detail. The electrical service enters overhead from the northwest and a subpanel was noted in the first bay of the shed there. Most if not all wiring is surface-mounted Romex. Most if not all outlets are GFI-protected. Switches couldn't be located for the ceiling lights in several of the shed spaces and these fixtures consist of open sockets with bare incandescent bulbs (as do those at the ceiling of the bleachers). No fire or smoke detectors were noted.

Photo 26: Detail of electrical subpanel on southwest wall in shed space L with unprotected open socket light fixture and miscellaneous wiring, cable, and GFI outlets.

- 5.1 Have the existing electrical system (including distribution, devices, and fixtures) inspected by a qualified electrician to verify their condition and safety.
- 5.2 Replace all open socket light fixtures with protected ones using either lenses, shades, or cages to reduce the potential for accidental breakage and related damage or injury.
- 5.3 Consider replacing all bulbs with more energy efficient versions.
- 5.4 Consider installing at least battery operated (though preferably hard-wired and connected to a monitoring station) fire & smoke detectors with alarms in the shed spaces and perhaps even the bleachers.
- 5.5 If the grandstand's exterior lights aren't connected to motion sensors consideration should be given to doing that for security.
